LANDFILL SITE AUDIT

Introduction

This initiative gave rise to the AfriForum landfill site audit report. This project determines the extent to which landfill sites in the municipalities in which AfriForum's 165 branches across South Africa are situated, comply with a simplified set of requirements based on waste management legislation and the licence conditions of landfill sites that set a benchmark for responsible waste management. In order to do this, landfill site audits were carried out in the relevant municipalities to determine whether the audit requirements for responsible waste management were being met. The audit results for each landfill site were analysed and converted to a score out of 100 to measure the site's compliance performance. The results of these audits are collated in this report.

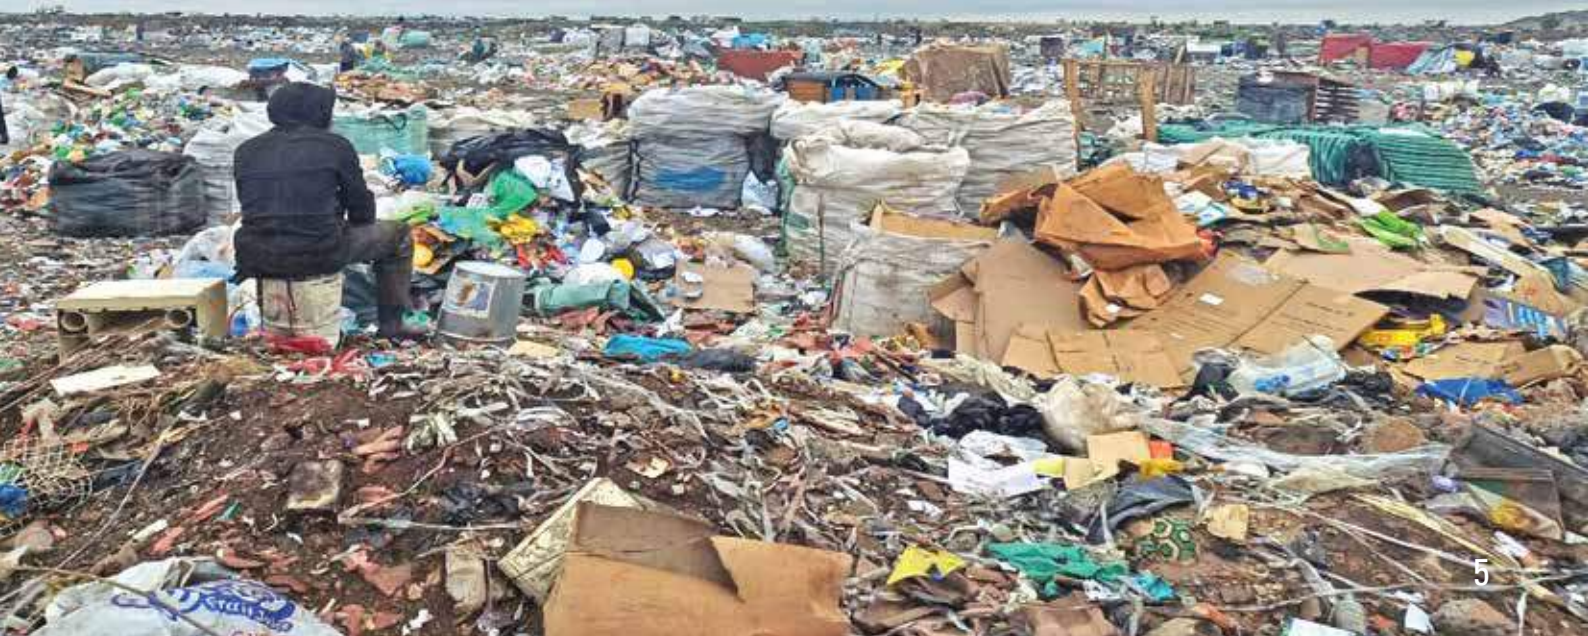
Informal recycling and shacks on the Bloemfontein South landfill site in the Free State.

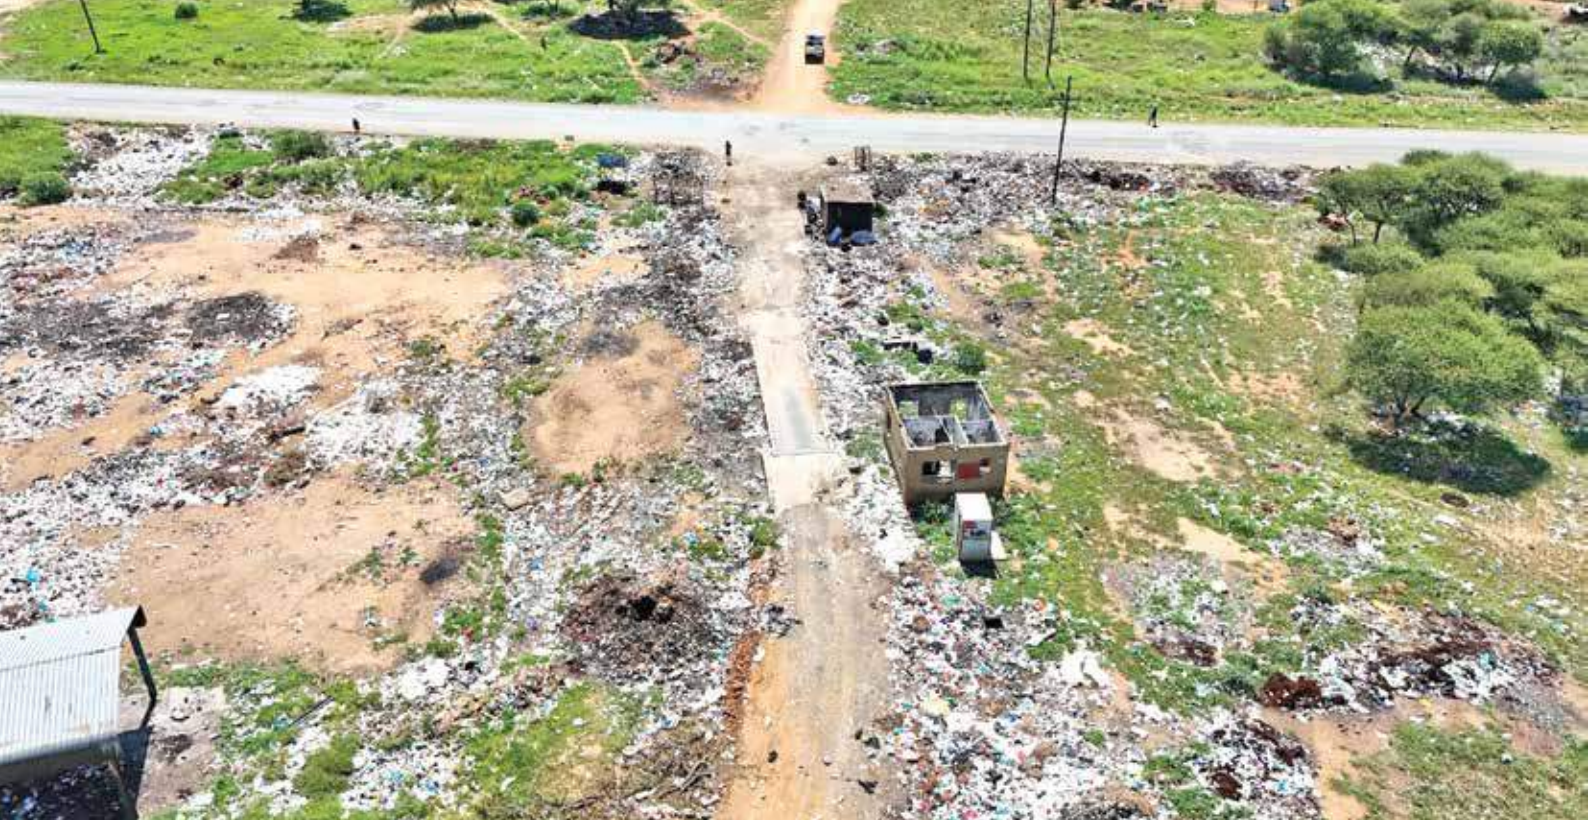
A broken weighbridge, looted infrastructure and lack of access control at Hartswater's landfill site in the Northern Cape.

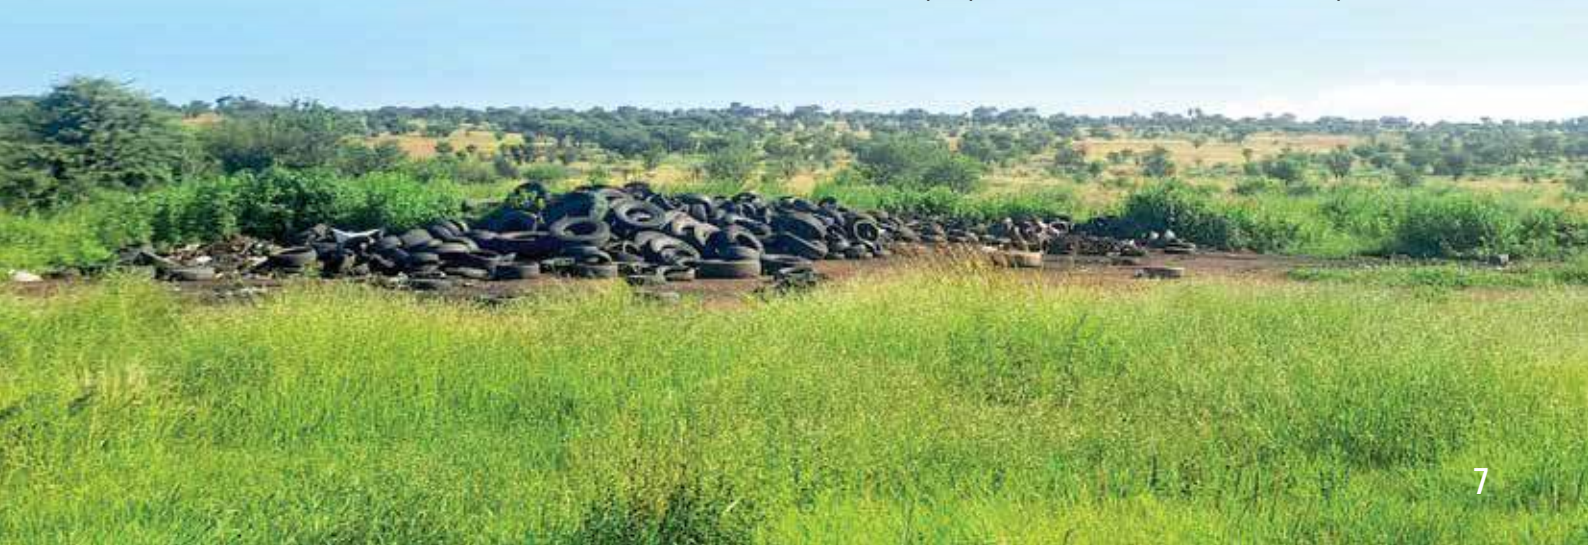
The illegal dumping of old tyres is a general problem on municipal landfill sites as seen here on Potchefstroom's Felophepa landfill site in the North West province.

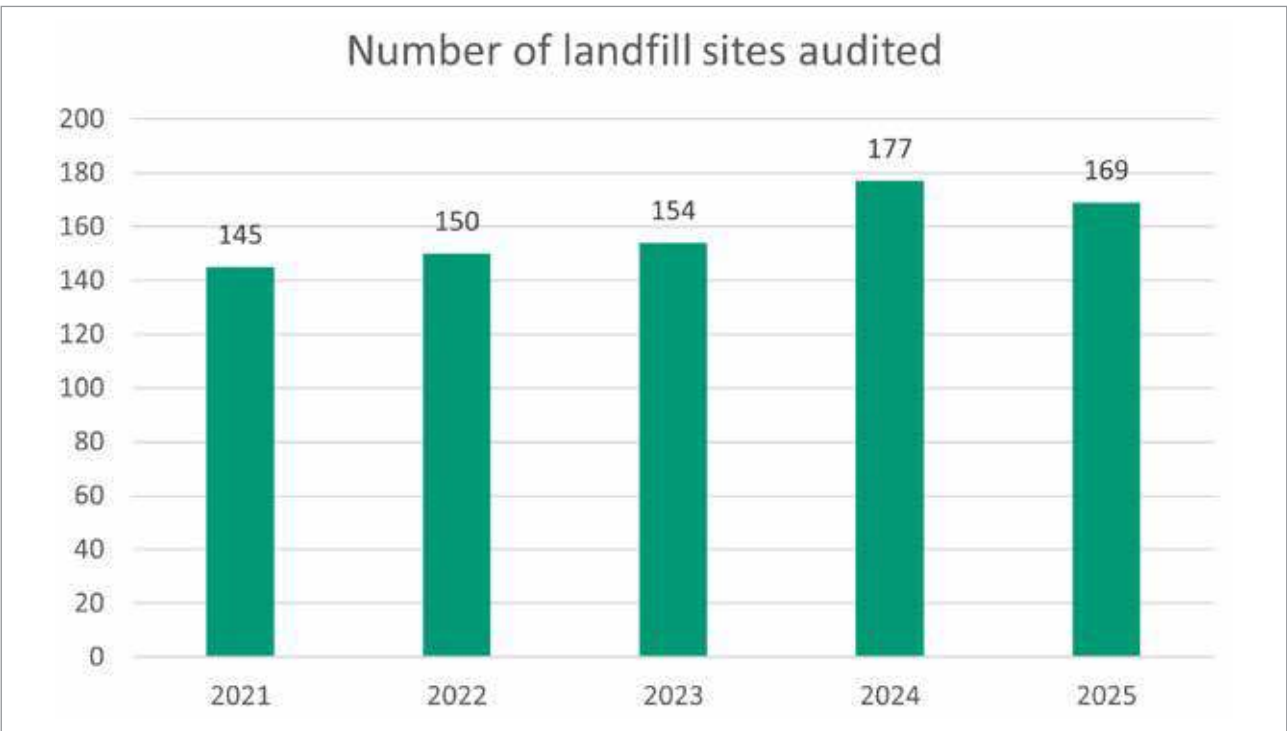
Figure 1: Number of landfill sites audited during the period 2021–2025

- Every year, efforts are made to expand the project. In 2025 a total of 169 landfill sites were audited, eight fewer than in 2024 due to operational constraints. Out of the 169, 166 were municipal landfill sites and three were private landfill sites.
- In addition to the 169 sites where audits were done, at some other sites audits could not be conducted because:
 - the site was closed by the relevant authorities (seven sites);
 - the site has already been rehabilitated (three sites); or
 - the site was too dangerous for the public to visit (one site).

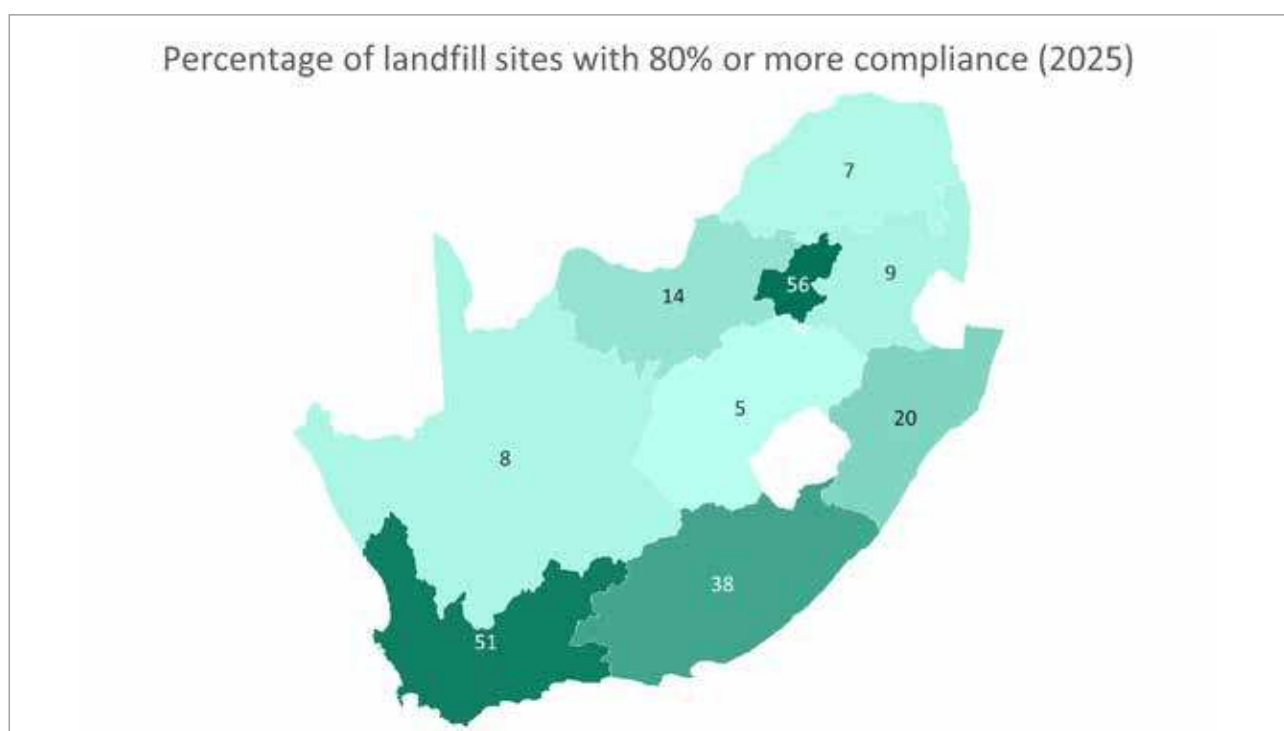
Figure 3: Percentage of landfill sites, per province, that passed the audit (2025)

- 38 of the 169 landfill sites that were audited in 2025 (22%) met the audit pass rate of 80% or more of the audit requirements.
- 131 of the 169 landfill sites that were audited in 2025 (78%) did not pass the audit.
- The province that had the highest average compliance score is Gauteng, where five of the nine sites (56%) met 80% or more of the audit requirements, followed by the Western Cape, with 19 of 37 sites (51%) that met the audit pass rate. These are the only two provinces where the majority of landfill sites passed the audit.

- Of the 38 sites that passed the audit:
 - 19 are in the Western Cape;
 - five are in Gauteng;
 - three each are in North West and the Eastern Cape;
 - two each are in KwaZulu-Natal, Mpumalanga and the Northern Cape; and
 - one each is in Limpopo and the Free State.
- More than 90% of landfill sites in the Free State, Limpopo, the Northern Cape and

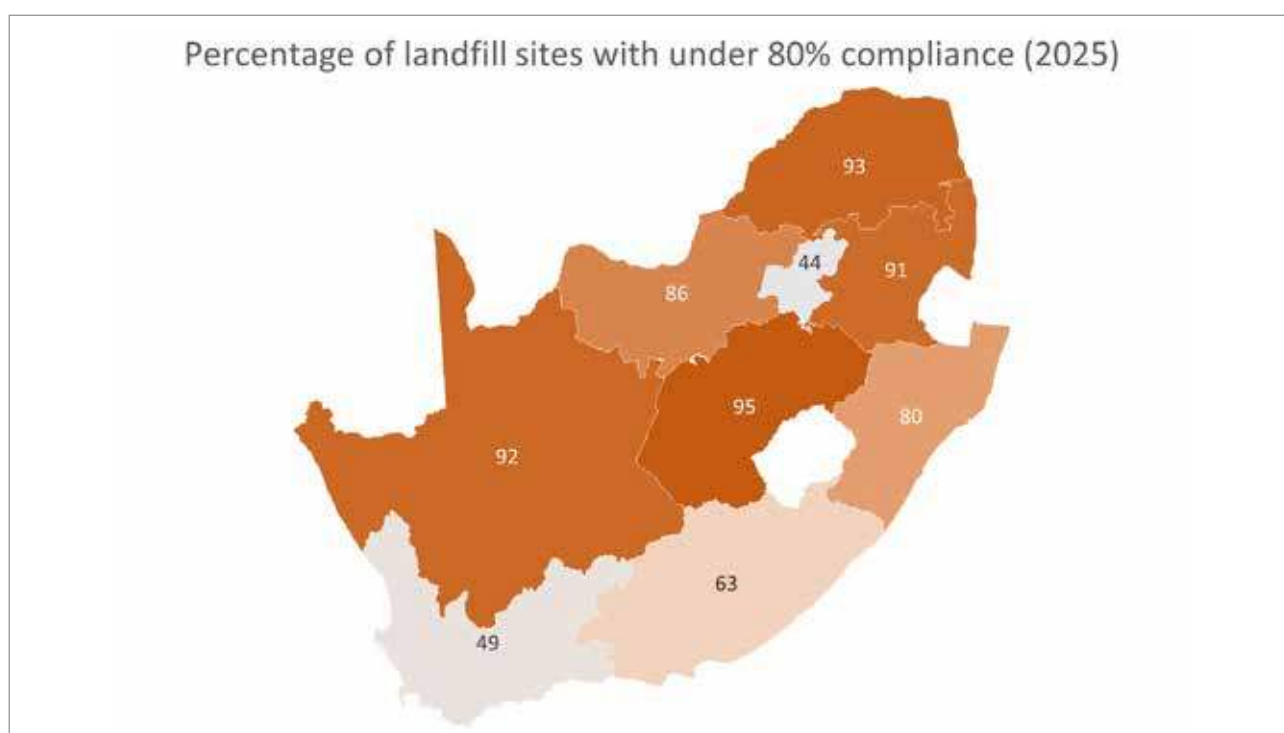
Figure 4: Percentage of landfill sites, per province, that did not pass the audit (2025)

Mpumalanga didn't pass the audit. The number of sites in each of these provinces that did not comply with the audit pass rate are as follows:

- 21 of the 22 sites (95%) audited in the Free State
- 13 of the 14 sites (93%) audited in Limpopo
- 23 of the 25 sites (92%) audited in the Northern Cape
- 21 of the 23 sites (91%) audited in Mpumalanga

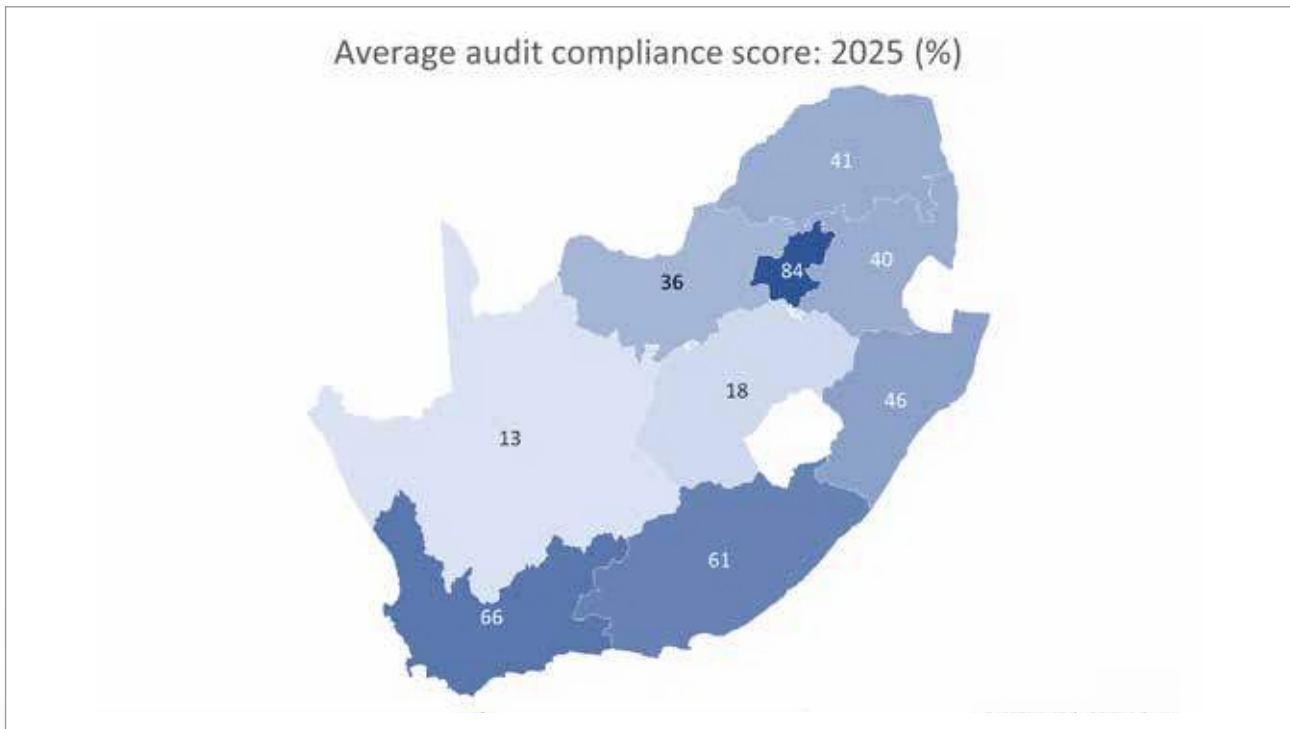
Figure 5: Average provincial audit score: 2025 (%)

- The national average compliance score in 2025 is 42%.
- The province with the highest average compliance score in 2025 is Gauteng (84%), followed by the Western Cape (66%).
- The province with the lowest average compliance score in 2025 is the Northern Cape (13%), followed by the Free State (18%).

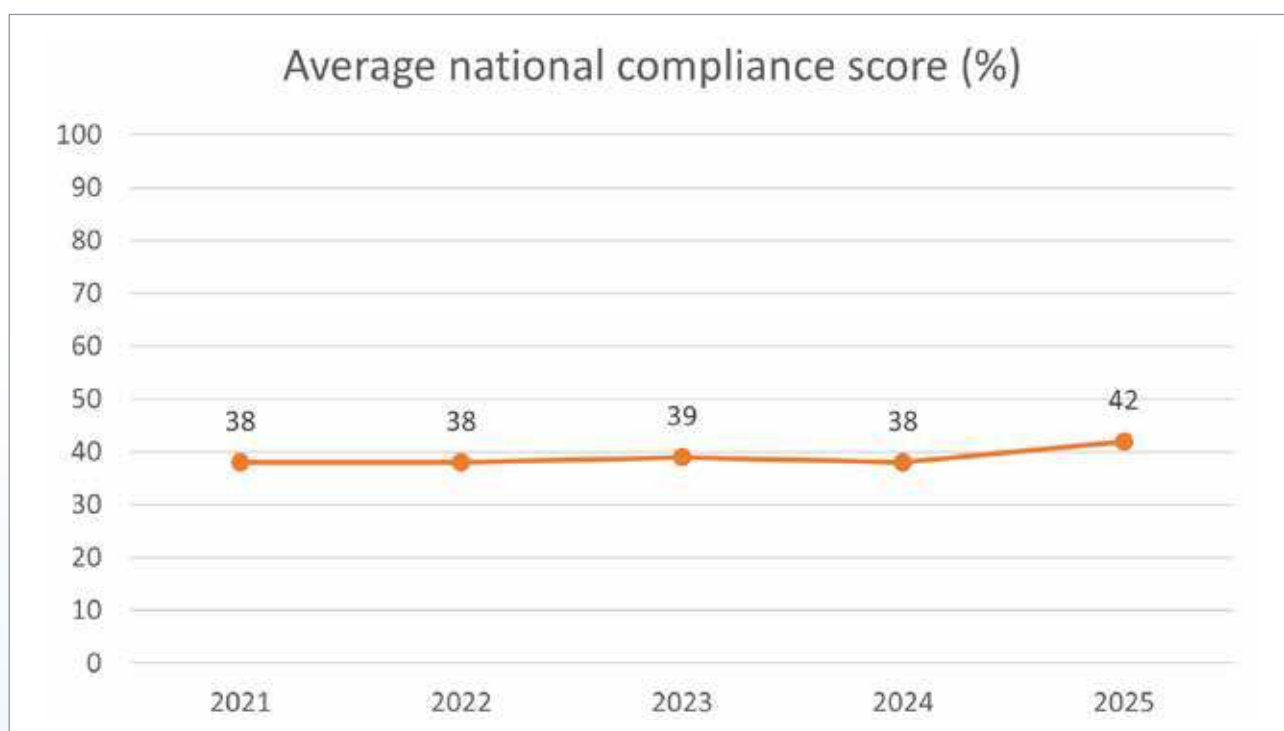
Figure 24: Average national audit compliance score: 2021–2025 (%)

- With 22% of landfill sites that met the audit pass rate of 80% or more of the audit requirements in 2025, this is the highest proportion of landfill sites that passed the audit in the past five years (18%, 19%, 18% and 16% in each of the years 2021–2024, respectively).
- Similarly, the national average compliance score of 42% is the highest in the past five years. The lowest national average compliance score during this period was 38%, reached in 2021.

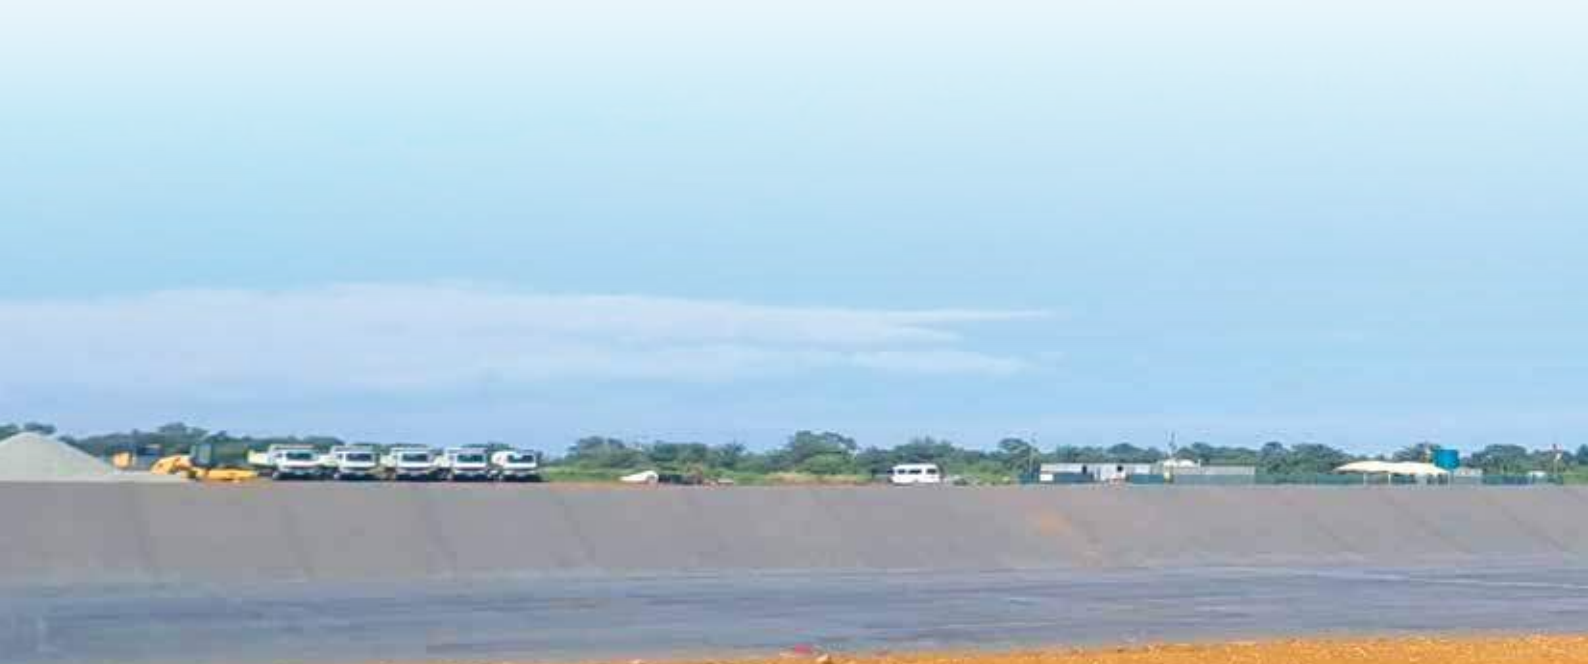
A new landfill cell lined with a membrane to prevent contaminated leachate from the landfill from contaminating the soil and groundwater, under construction at the Felophepa municipal landfill site in Potchefstroom, North West.

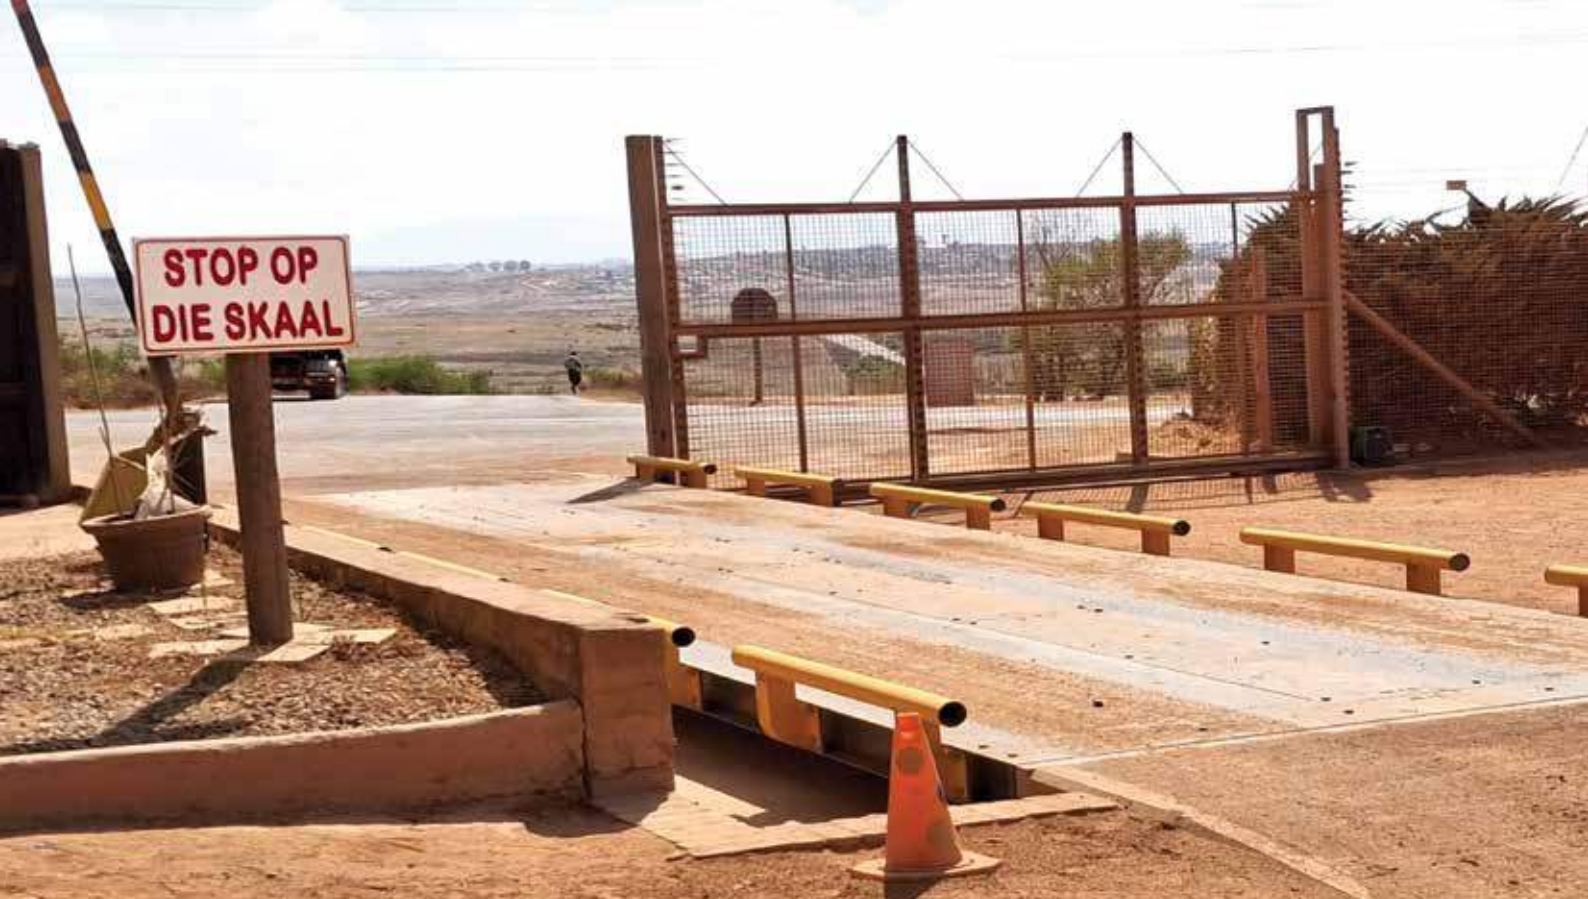
A working weighbridge and access control at the Malmesbury Highlands municipal landfill site in the Western Cape – one of only a few sites that can boast a 100% compliance rate in 2025.

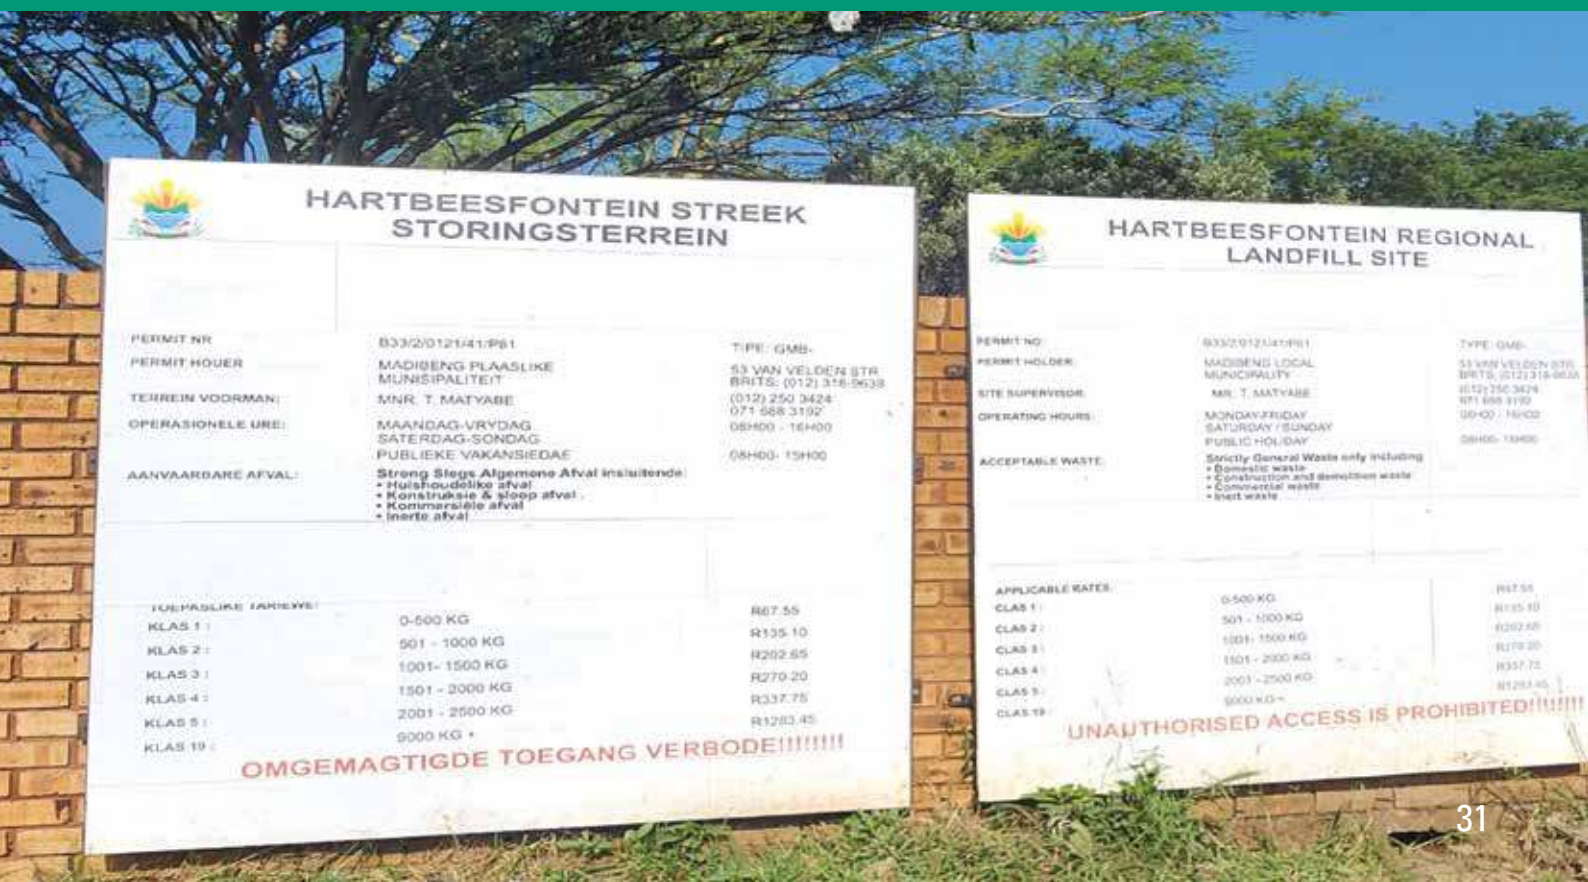
Information such as the permit number, business hours and dumping tariffs are clearly displayed at the entrance to the Hartbeesfontein municipal landfill site in Brits, North West – one of only three out of 21 landfill sites in this province that passed the audit in 2025.

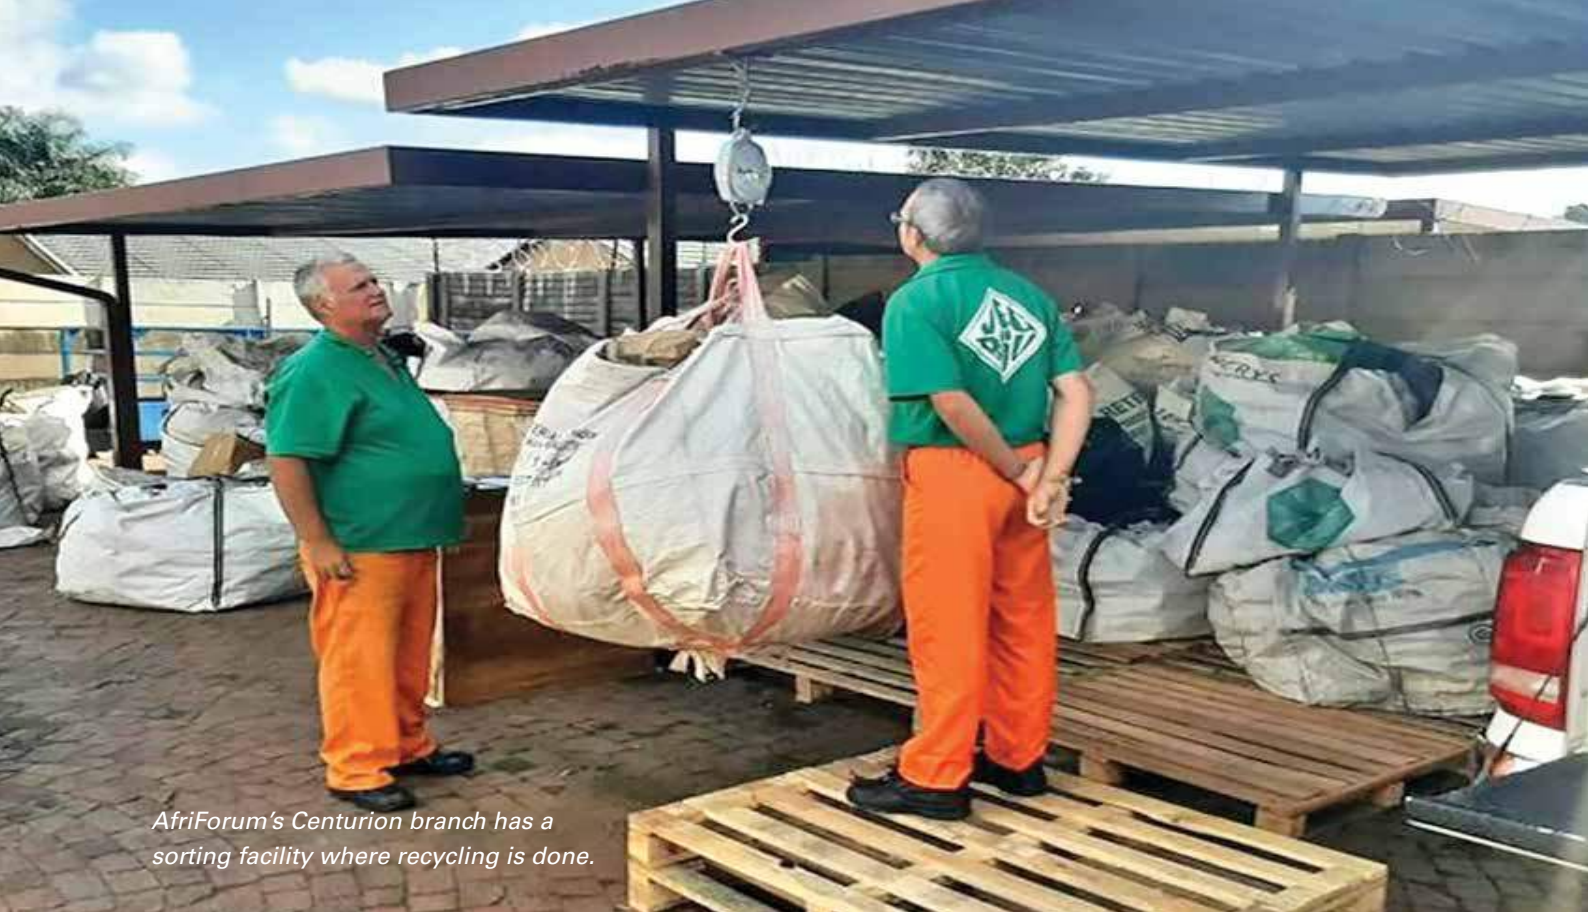
AfriForum's Centurion branch has a sorting facility where recycling is done.

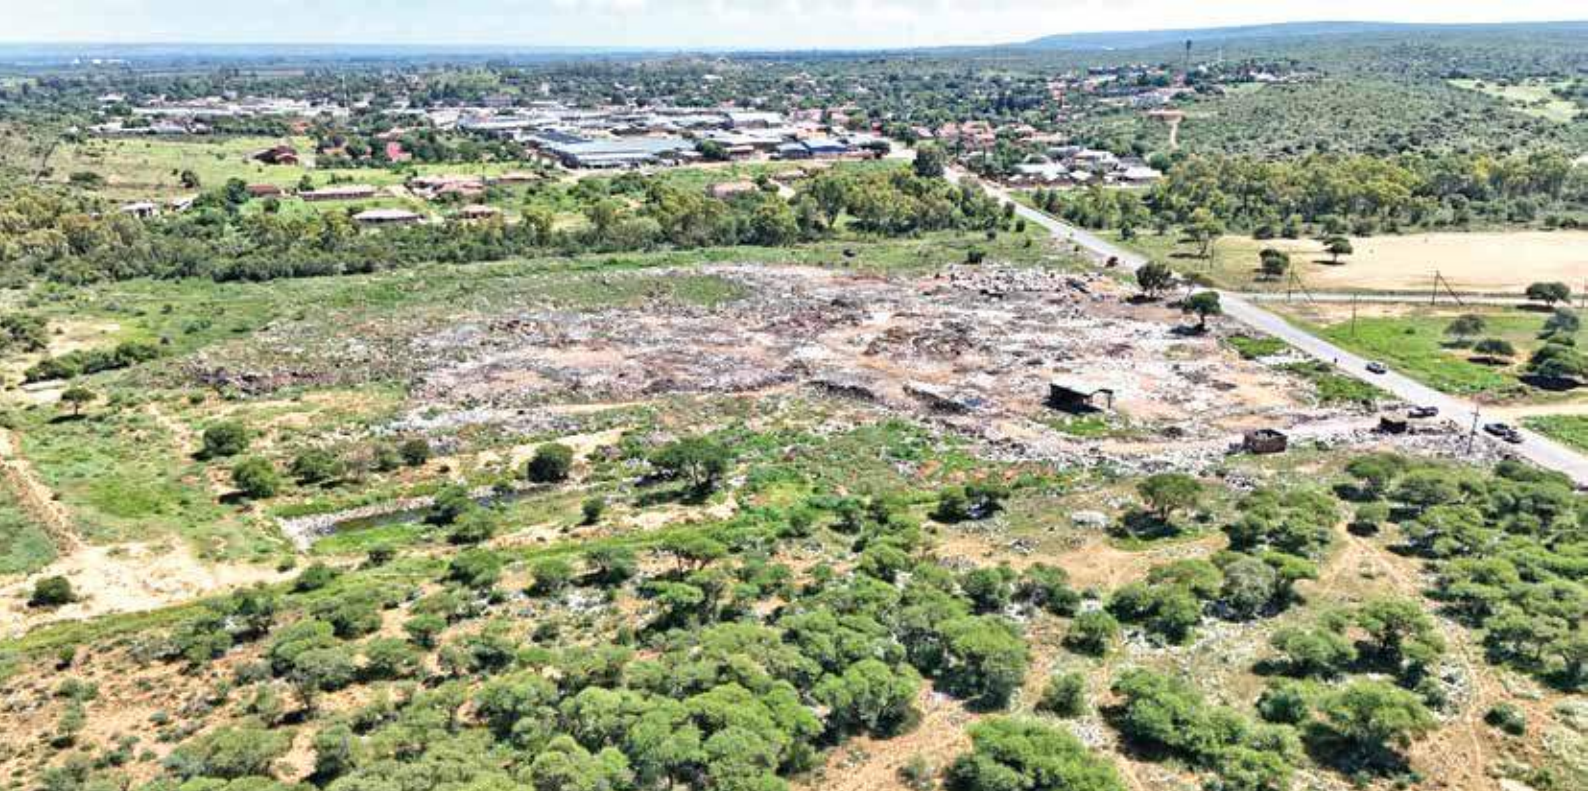
With a compliance score of 0%, the Hartswater municipal landfill site in the Northern Cape is the epitome of irresponsible landfill site management: There is no access control, the waste being dumped is not inspected, and the illegal dumping of tyres and carcasses has been observed. There is no working machinery or personnel present to implement an operational plan, which means waste is not compacted or covered with soil; waste and smoke from burning waste is blown by the wind into neighbouring residential areas, and the site is occupied by informal recyclers.
